Manhole Inspection Summary

Manhole # S13OO1005MH

Insp Date: **11/29/06 9:50 AM**

Location Address: **2716 WOODLAND AVE**

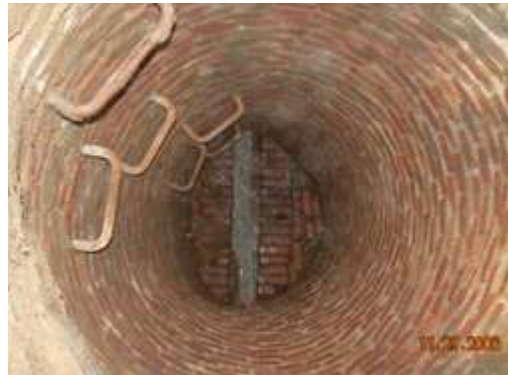
Top View

Bench ☒ Exists Material: **Brick** ☐ Parged ☒ **Debris** (not Condition related)

Steps Count: **7** Missing: **0** ☒ **Corroded**

Corroded steps. Bench debris.

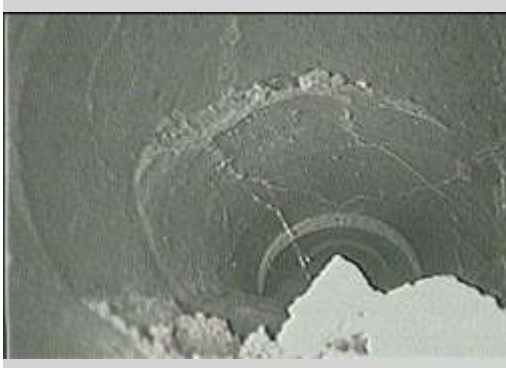
Inside of the I4 pipe

Fractured and broken pipe.

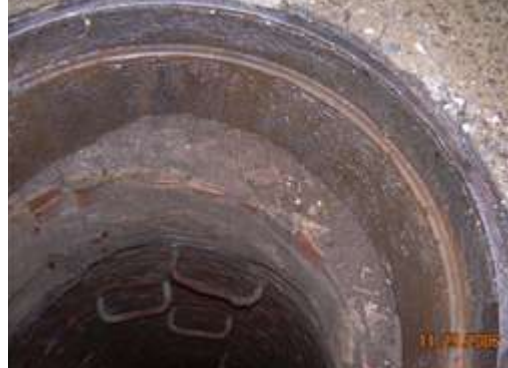
Defect

Frame Offset: **3** (in.) Condition: ☐ Sound ☐ Cracked ☒ **Leaks**

Infiltration: ☐ None ☒ **Joint** ☐ Cracks ☒ **Mortar** ☐ Roots ☐ Wall

Frame leaks. Frame offset. Adjustment infiltration.

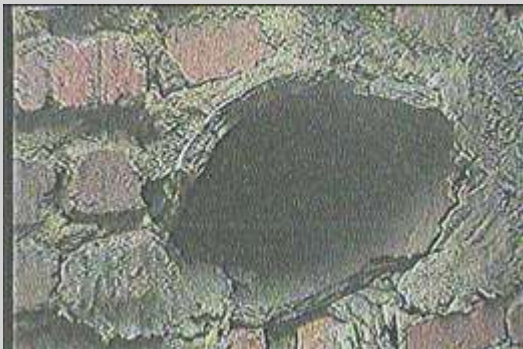
8 in. Circular Gravity Sewer Pipe In @ 4 O'Clock

Condition: ☐ Sound ☐ Cracked ☐ Root Intrusion ☐ Loose Brick ☒ **Deteriorated**

Infiltration: ☐ None ☐ Joint ☐ Cracks ☒ **Mortar** ☐ Roots ☒ **Wall**

Barrel deterioration.

Infiltration: **None** Pipe Seal Cond: **Broken**

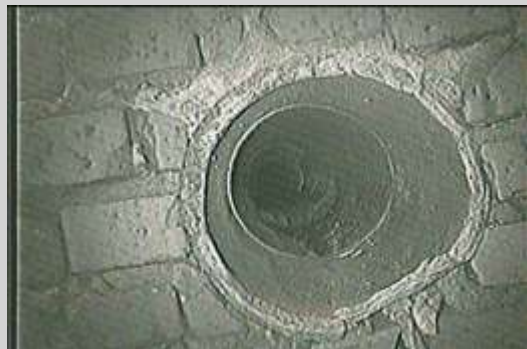
Pipe In @ 6 O'Clock

Infiltration: **Evidence**

Pipe Seal Cond: **Broken**

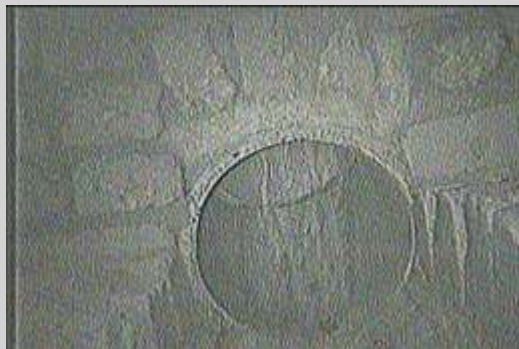
Drop In @ 6 O'Clock

Drop Condition: **Open**
